Forty-Eighth Annual Field Conference

April 28, 1973

ASPECTS OF THE ENGINEERING-ENVIRONMENTAL GEOLOGY
IN THE LOWER CUYAHOGA RIVER VALLEY,
OHIO

GEORGE D. GARDNER
GENERAL ANALYTICS, INC.

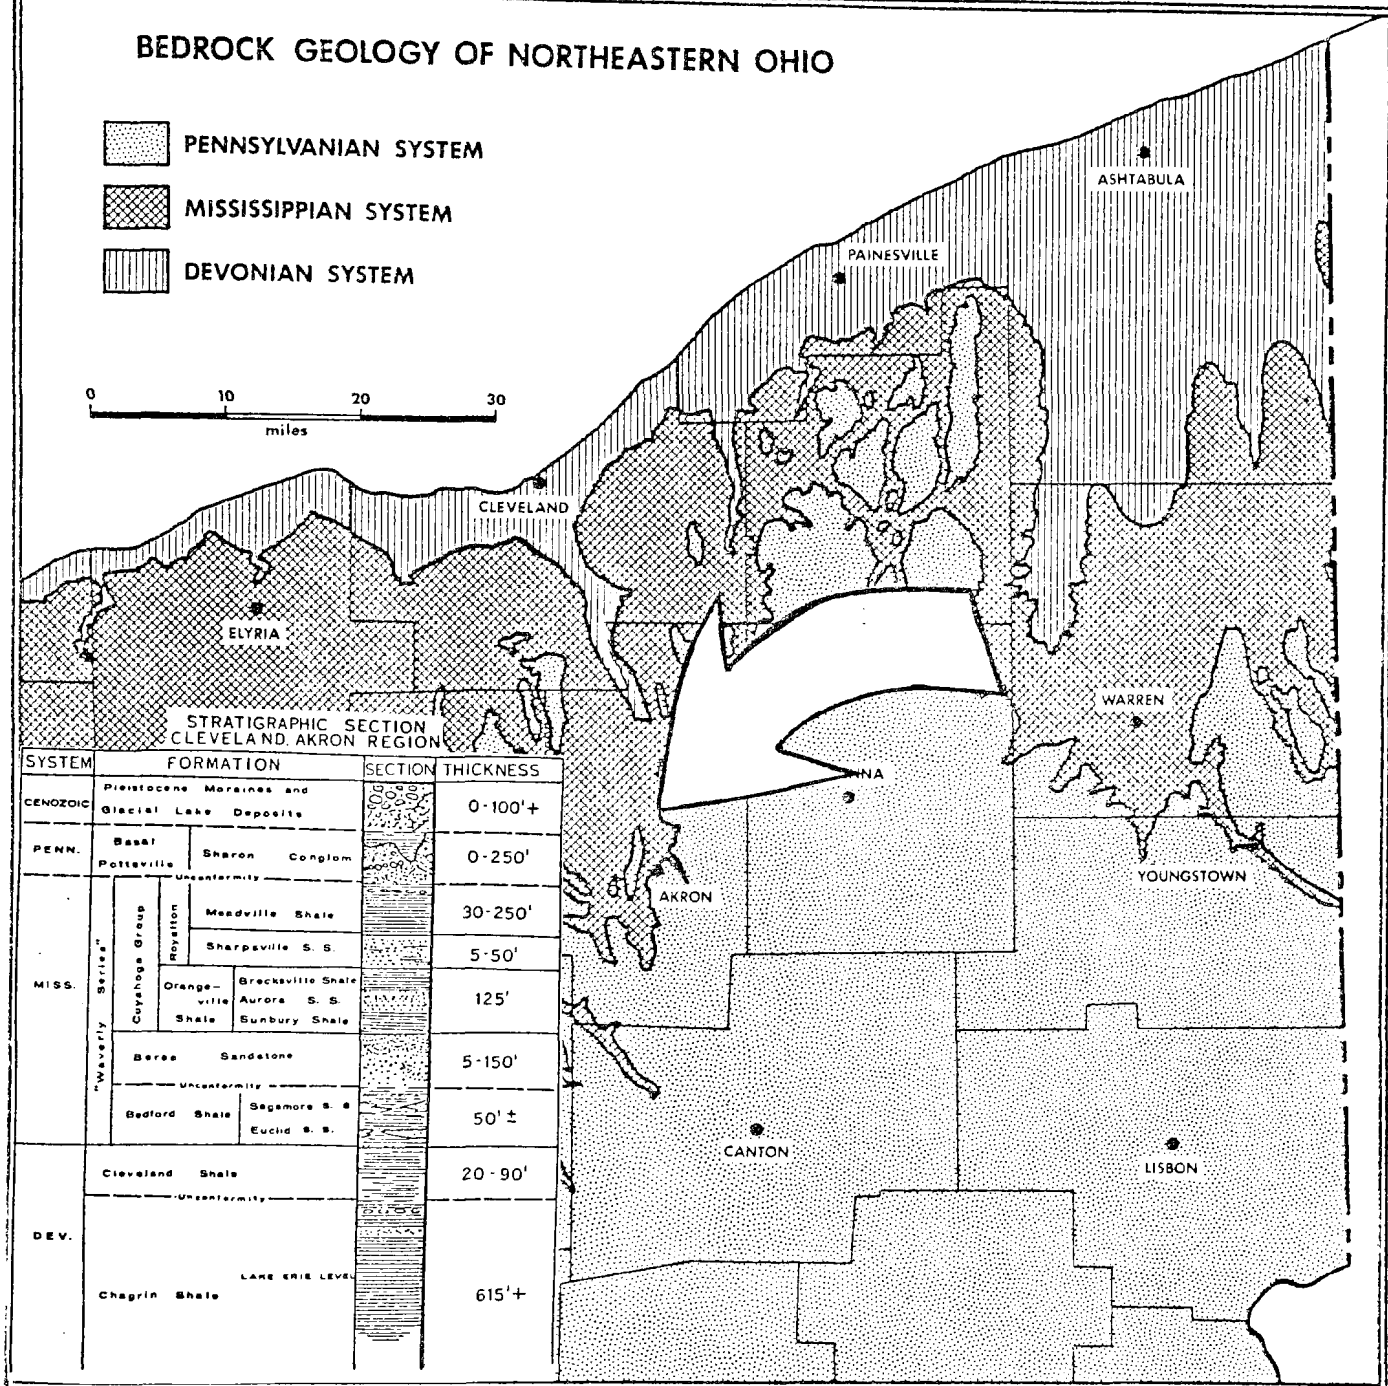
Figure 1. Generalized bedrock geology and stratigraphic section for Northeastern Ohio (approx. location of field trip area designated by white arrow). Figure adapted from: Guide to the Geology of Northeastern Ohio, P.O. Banks and R.M. Feldmann (eds.), Northern Ohio Geological Society, 1970, pp. 6.

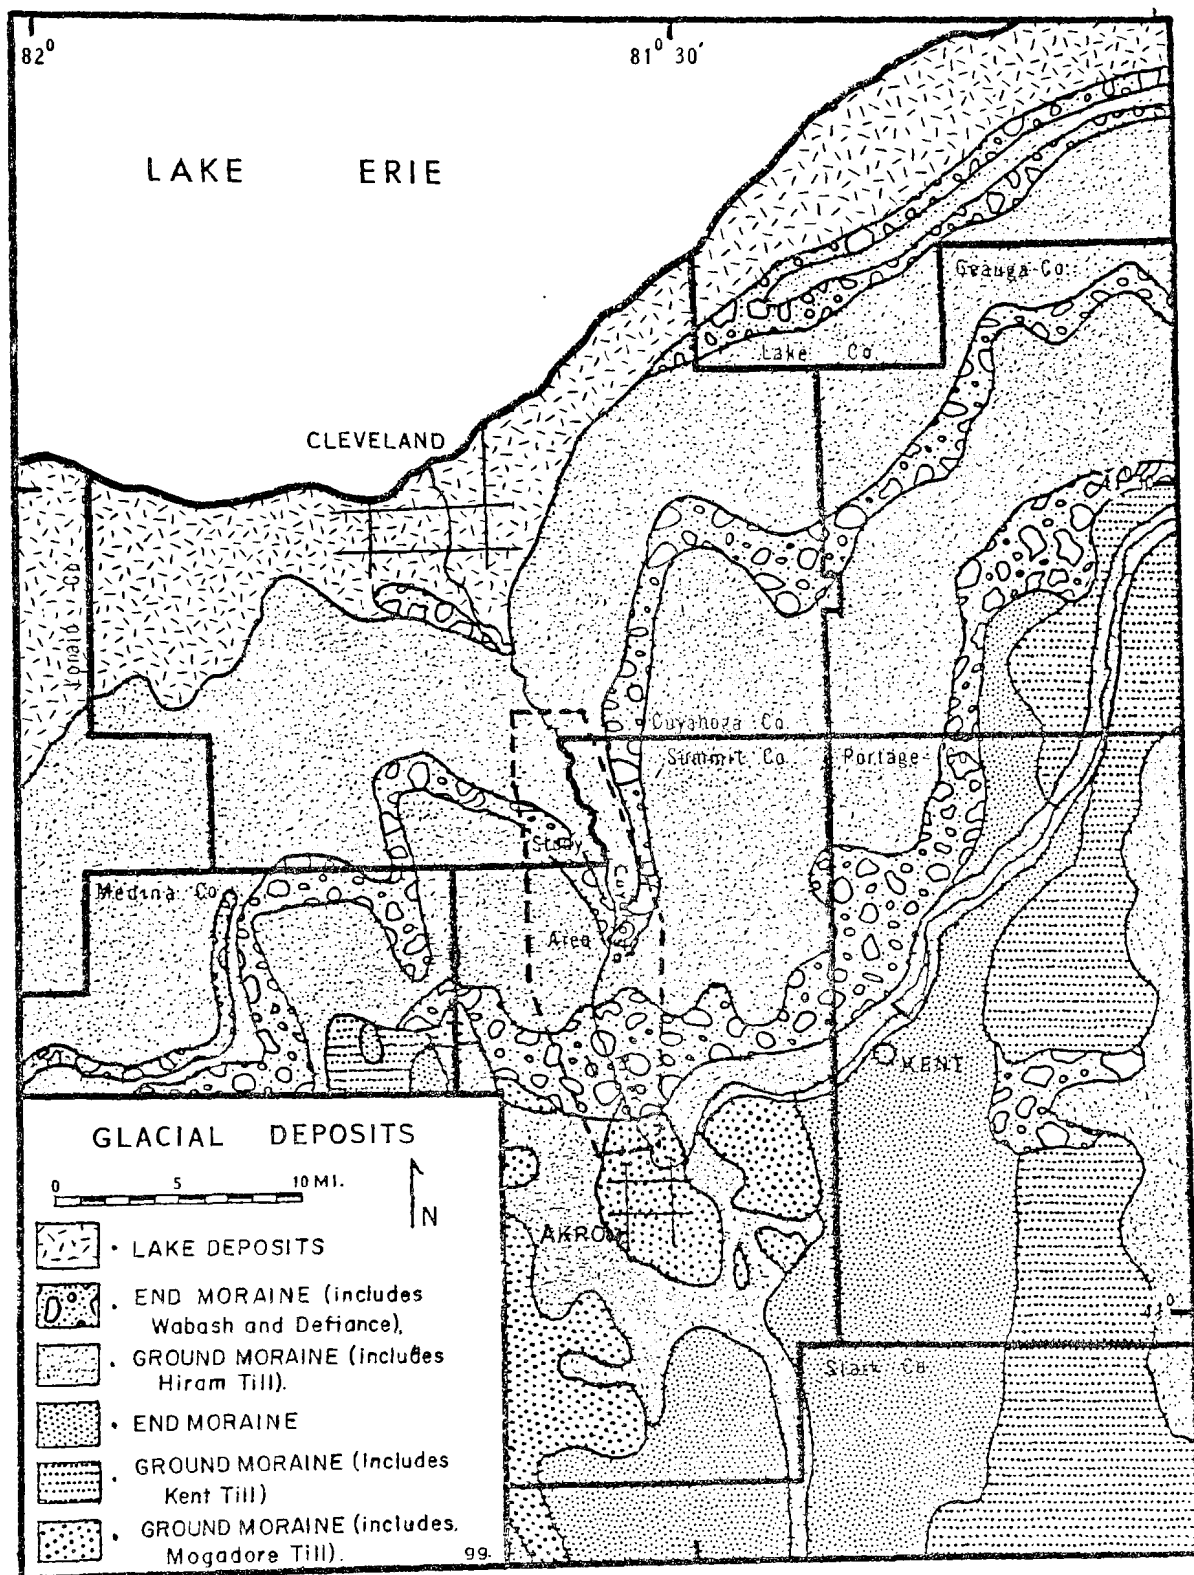
Figure 2. Glacial map of study area and vicinity (White, 1953b).
